Manhole Inspection Summary

Manhole # S04YY1007MH

Insp Date: **7/5/06 10:01 AM**

Location Address: **3800 MIDHEIGHTS RD**

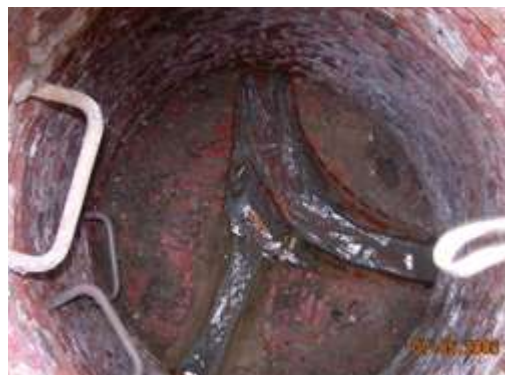
Top View

Adjustment and Barrel infiltration. Corbel deterioration and infiltration. Evidence of surcharge - Bench debris.

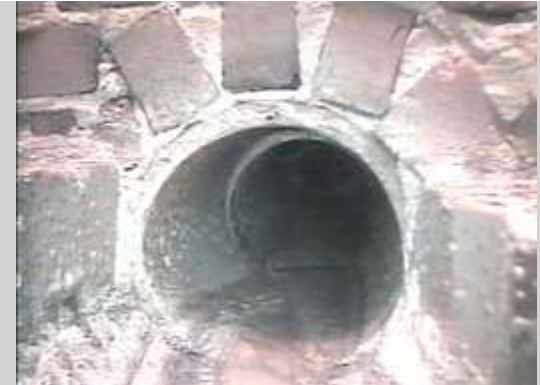
8 in. Circular Gravity Sewer Pipe Out @ 12 O'Clock

Barrel deterioration and infiltration. Channel deterioration.

Infiltration: **Evidence** Pipe Seal Cond: **Unknown**

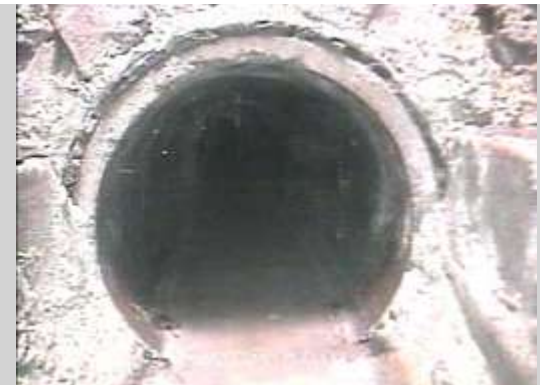
8 in. Circular Gravity Sewer Pipe In @ 4 O'Clock

Infiltration: **Evidence** Pipe Seal Cond: **Unknown**

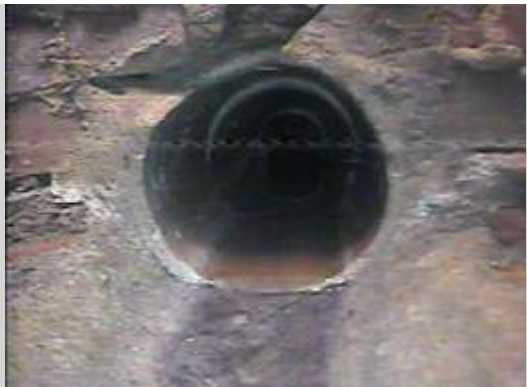
6 in. Circular Gravity Sewer
Pipe In @ 7 O'Clock

Deposits: ☐ None ☐ Mud ☐ Sludge ☐ Debris ☒ **Grease**

Silt Depth: **0** (in.) Deposits Extent: **Light**

Infiltration: **Evidence** Pipe Seal Cond: **Broken**
